Correction of OSC2 to OSC3 signal flow

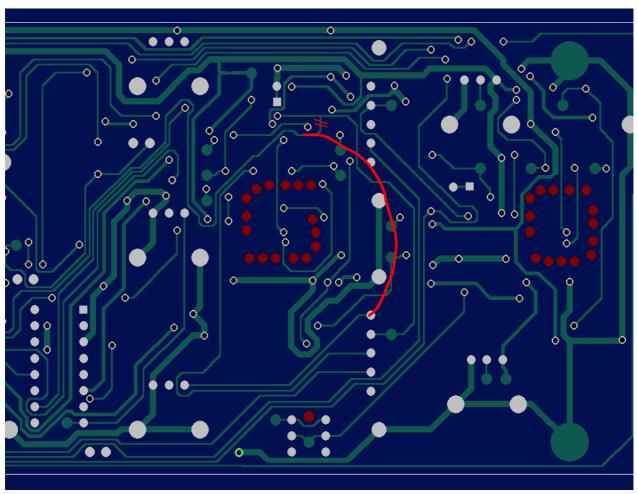
From serial 50100 to 50150 there is the following mistake in the Neptune II. Signal source for OSC3 in switch position "VCO 2" can only be the saw wave of OSC2 but it should be selectable of pulse, saw or external input.

It is needed to cut the track in the picture below on the backside of the pcb and to scratch soldermaskfree a short part of the remaining track and to add a wire like shown in this picture:
